**NUMBER:** 23-043-02

Sunshade May Partially Close During Hard Application Of The Service Brakes

2002 (WJ) Grand Cherokee  
2002 (WG) Grand Cherokee (International Markets)

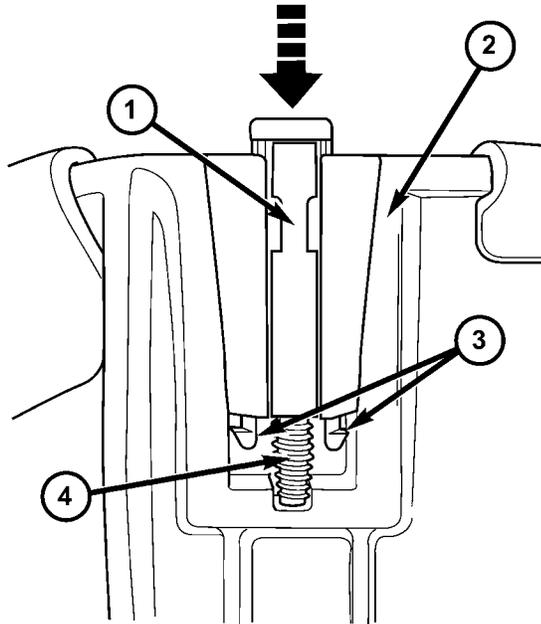
**Fig. 1 SUNSHADE GUIDE BLOCK AND SPRING**

- 1 - Sunshade Guide Block (Replace)
- 2 - Sunshade
- 3 - Guide Block Locking Tabs
- 4 - Guide Block Spring (Replace)

8. Disengage the rear guide blocks from the sunroof track.
9. Replace all four sunshade guide blocks and springs. Compress the guide block locking tabs to remove the old block and spring (Fig. 1).

**NOTE: MAKE CERTAIN THAT BOTH GUIDE BLOCK AND SPRING ARE REPLACED.**
